# Final Report

## Crime Prevention through Environmental Design (CPTED) for Public Transit Stations

**Jennie Perey Saxe, Ph.D.**

University of Delaware

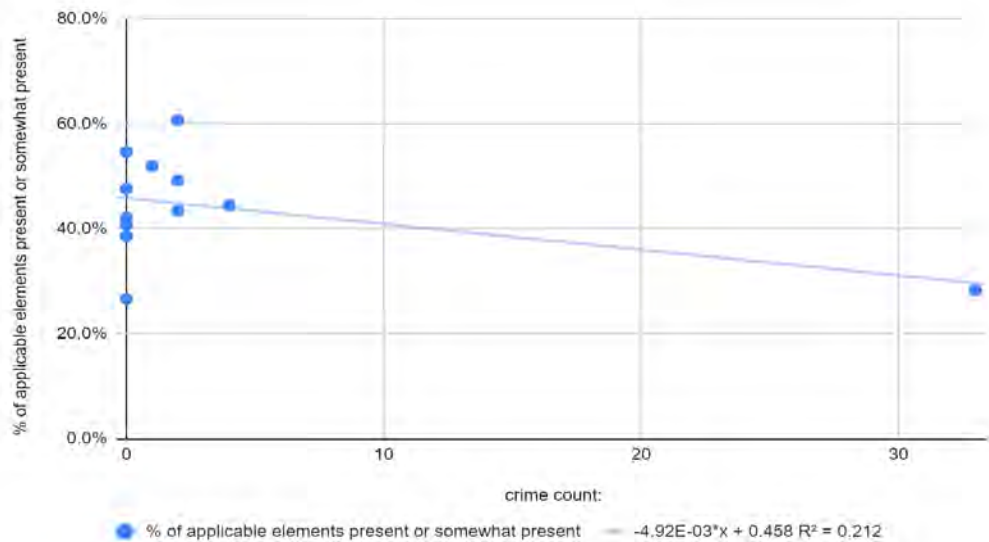
**Figure 3.2: Percent of applicable elements present/somewhat present vs. count of crimes at sites in the study.**

The team used state and county police crime data to determine the number of reported crimes in the previous 180-day period. All sites but one were characterized by fewer than four reported crimes during this period; half of the sites were in areas with no reported crimes during this timeframe. The site with the highest number of reported crimes (site J) had the second-lowest percentage of applicable CPTED elements “present” or “somewhat present”. The correlation between the number of crimes reported and the proportion of applicable CPTED elements present is not particularly strong (Figure 3.2). Removing site J (33 crimes reported in the 180-day period reviewed) weakens the correlation even further.

Based on the relatively small sample size (12 sites) the team did not find a clear correlation between lack of CPTED elements and higher rates of reported crime. The Pew Research Center notes that violent and property crimes are likely

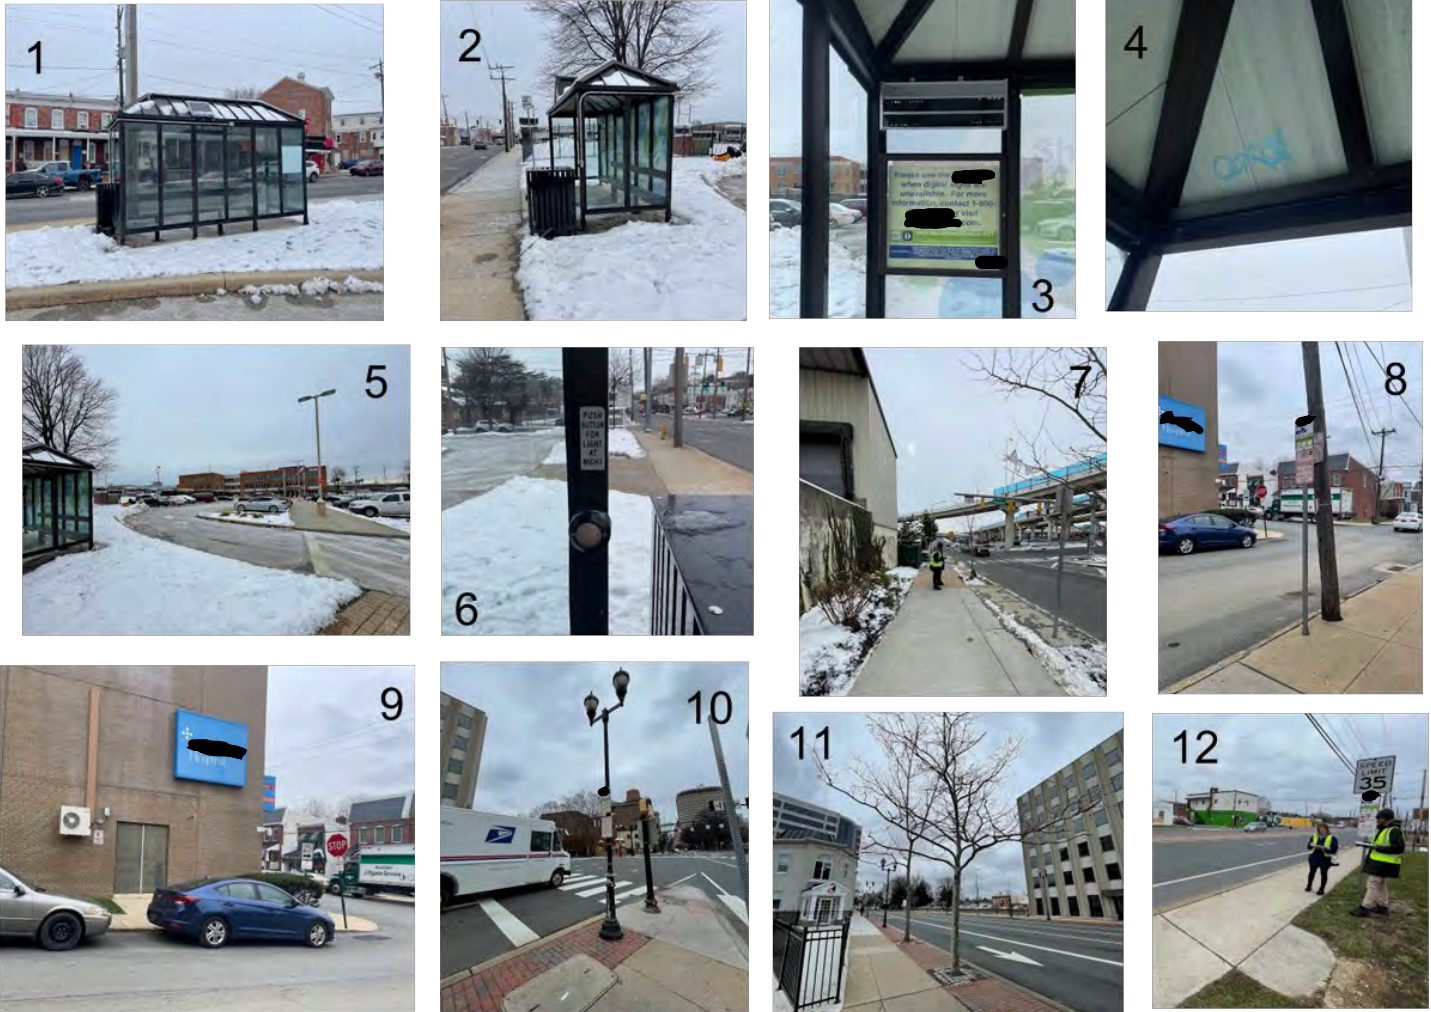
1. Site B – even with advertising, the walls of the shelter provide visibility.
2. Site B – waste receptacle, signage, set-back and sidewalk, advertising visible on back wall of shelter.

3. Site B – signage could also encourage safety or maintenance needs to be reported via app; scratch in paint to right of sign.
4. Site B – a small amount of graffiti.

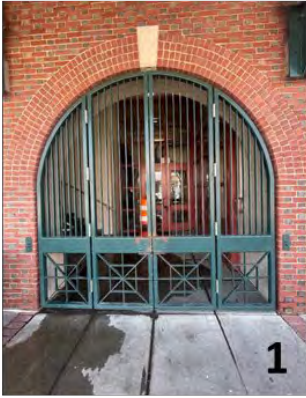
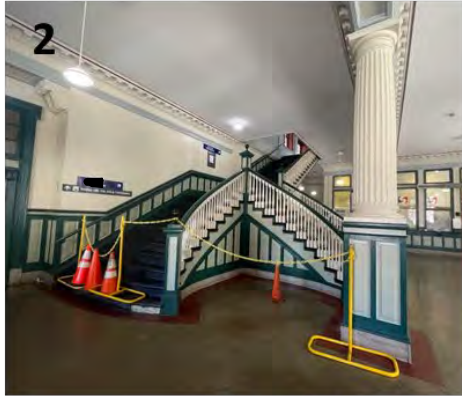
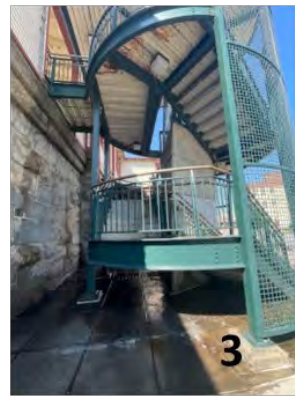
1. Site G gated tunnel to prevent unauthorized access.
2. Site G interior; this side of the stairway and column are not visible directly from the operator booth (background); an installed mirror provides some visibility; also visible is bright paint and lighting.

3. Site G exterior stairway to southbound platform with maintenance need; lighting adequacy not assessed; some hiding spots due to the central shaft of the stairway.
